61 M h/o left THA revision with recurrent dislocations

Melanie Chang
5/19/2017

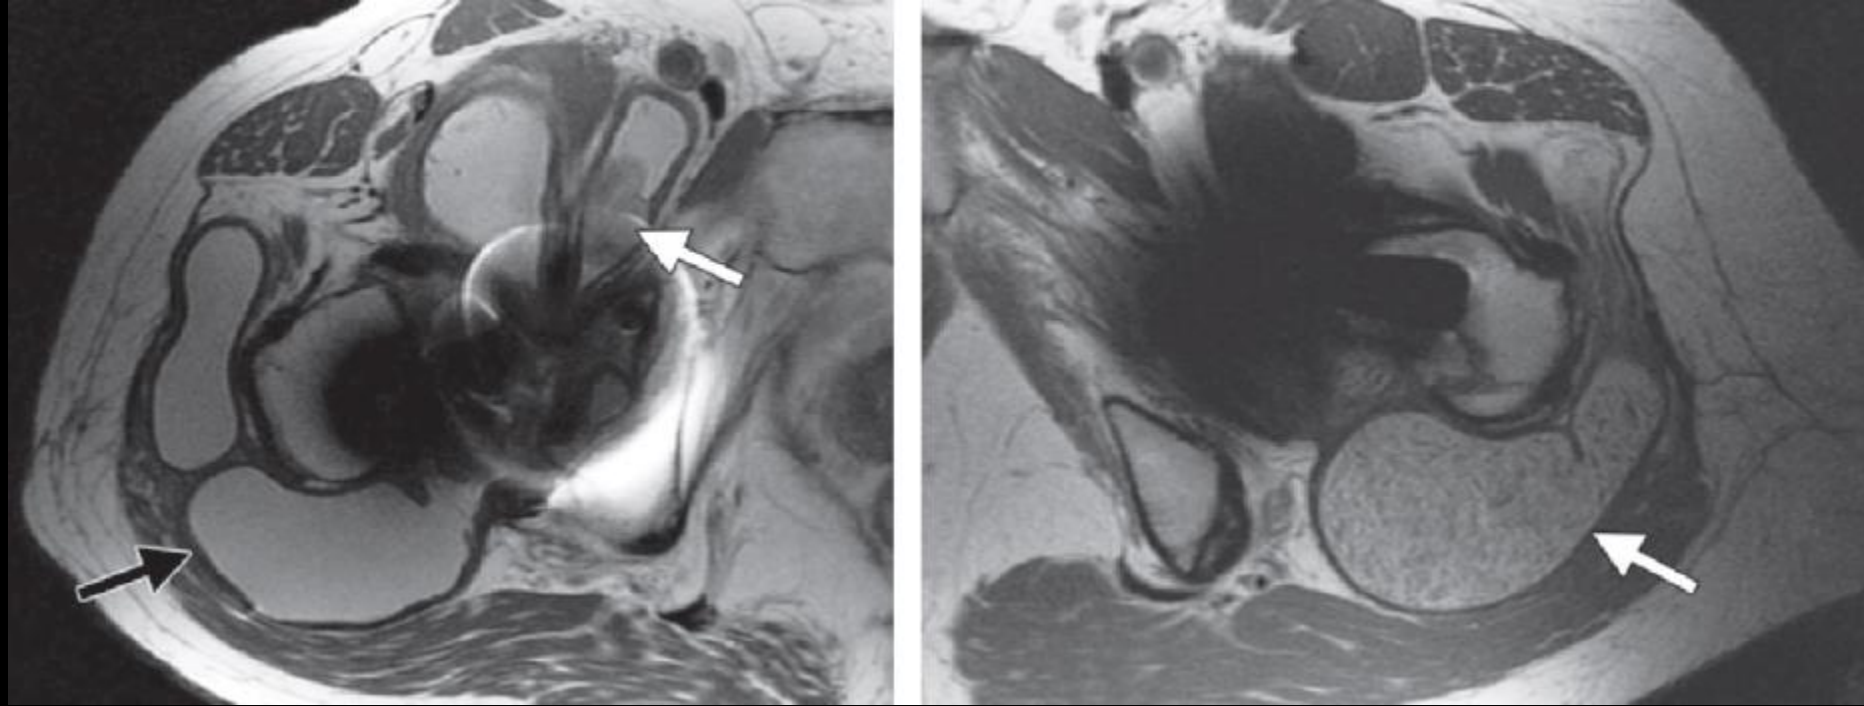
Implant-related wear

Mechanical wear- can result from abrasion of well-positioned opposing metallic bearing surfaces, neck-on-cup impingement, or edge loading

- Edge loading results when there is abnormal load distribution across bearing surfaces that is due to component positioning outside the “safe” zones of anteversion and inclination

Corrosion- electrochemical type of wear, source of free metallic products, problematic at the neck-stem junctions or head-neck junctions of modular arthroplasty systems
