32F with h/o ACL reconstraction, woke up with knee pain one week ago.

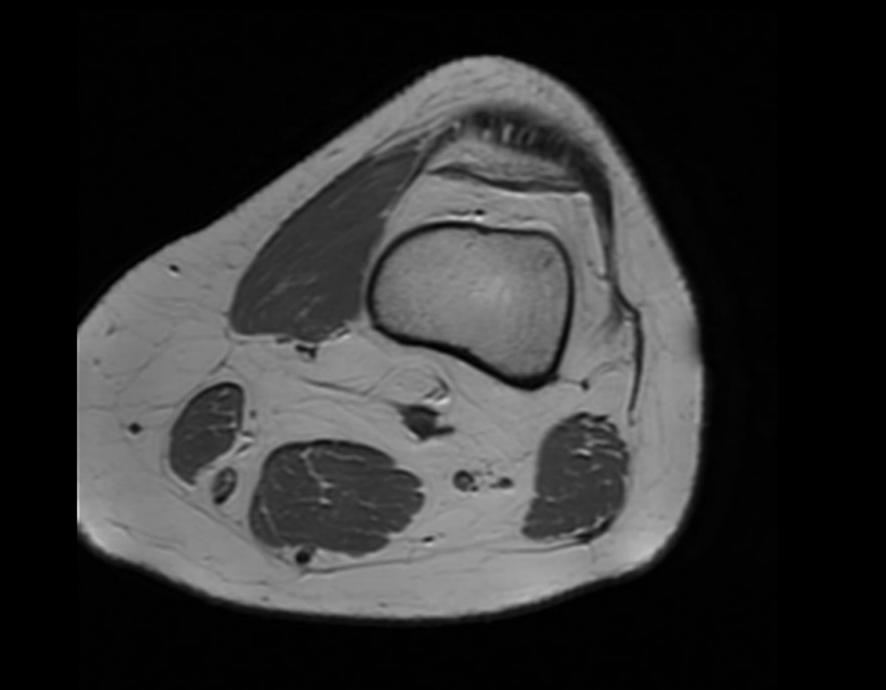
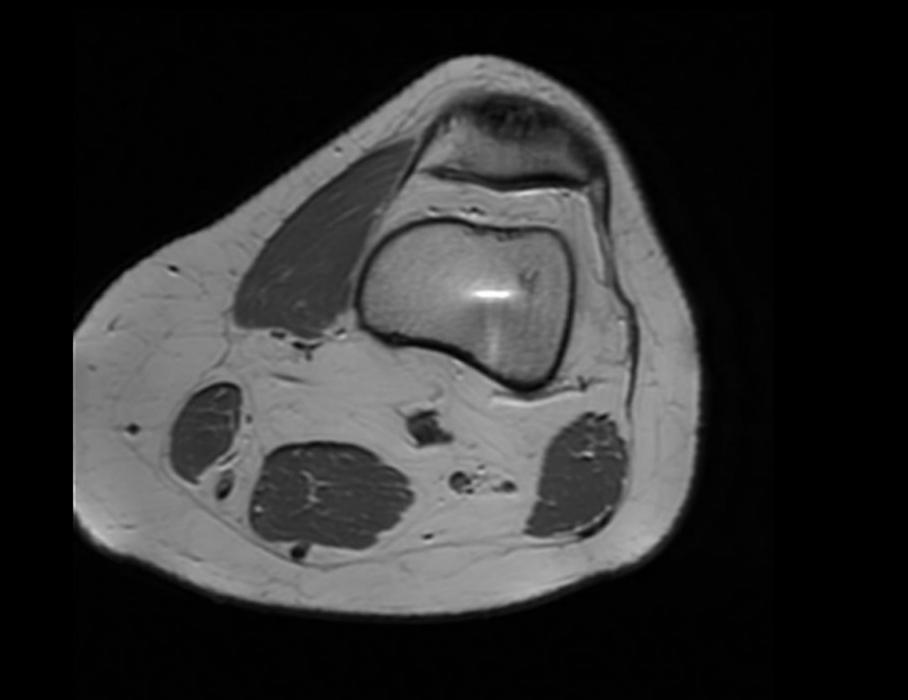
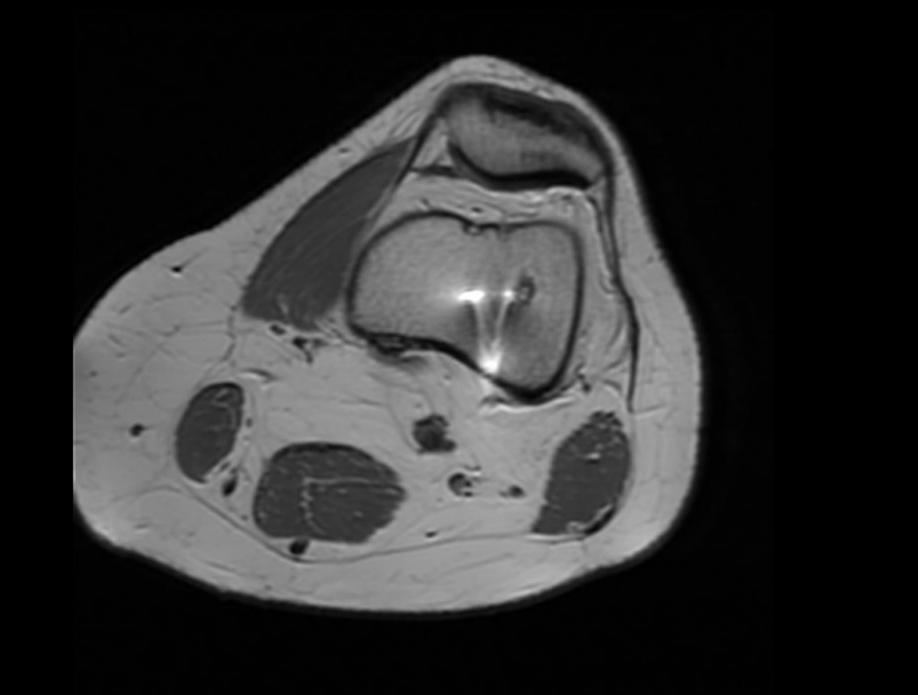
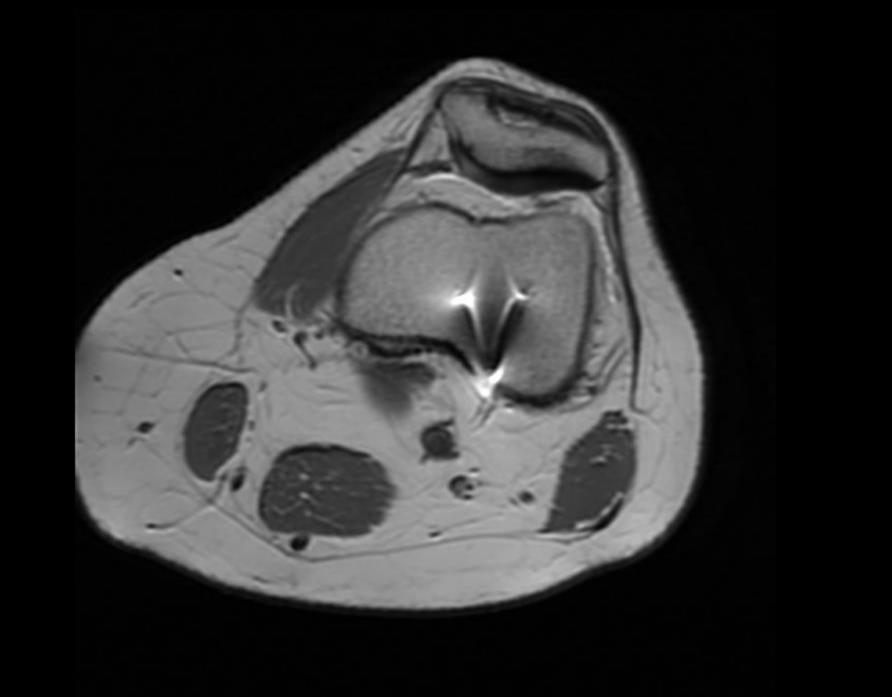
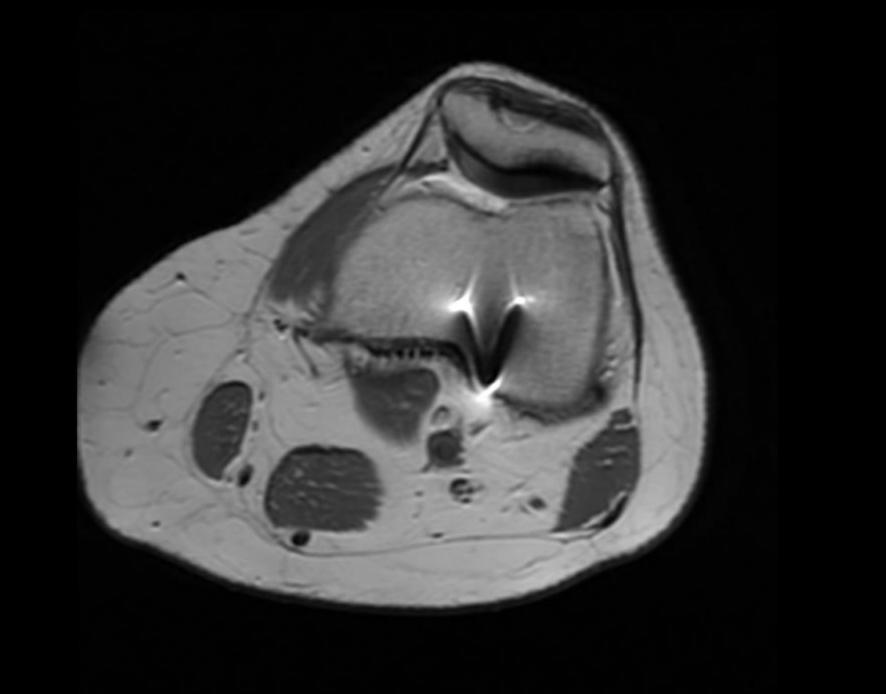
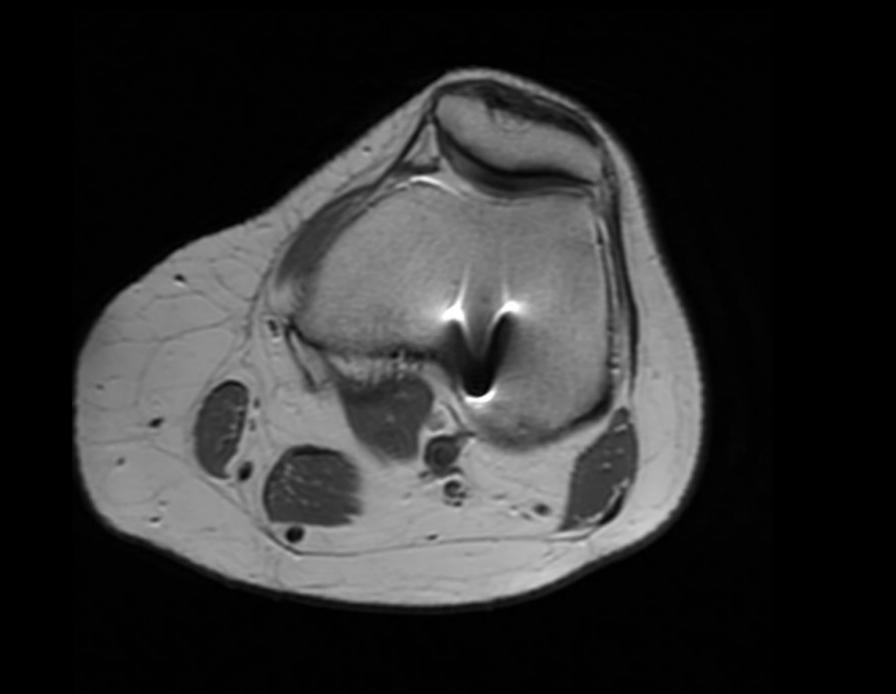
• a dark signaling, linear or curvilinear structure subjacent to the patellar articular surface

Always lateral patella

- always located in the lateral patellar facet
- a curvilinear configuration subjacent to the overlying articular surface
- best seen in the sagittal plane on the PD-weighted
- usually present on 2–3 contiguous slices
- less well seen on the sagittal fat-suppressed T2-weighted images, only faintly seen on the axial fat- suppressed T2-weighted images
- Better seen in younger patients

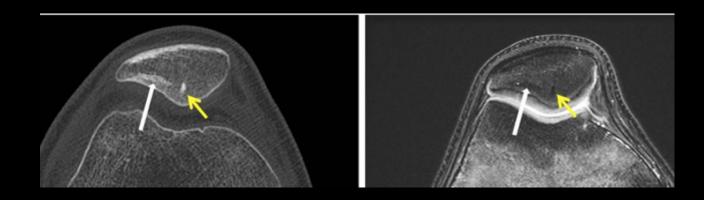
Was even better seen on CT

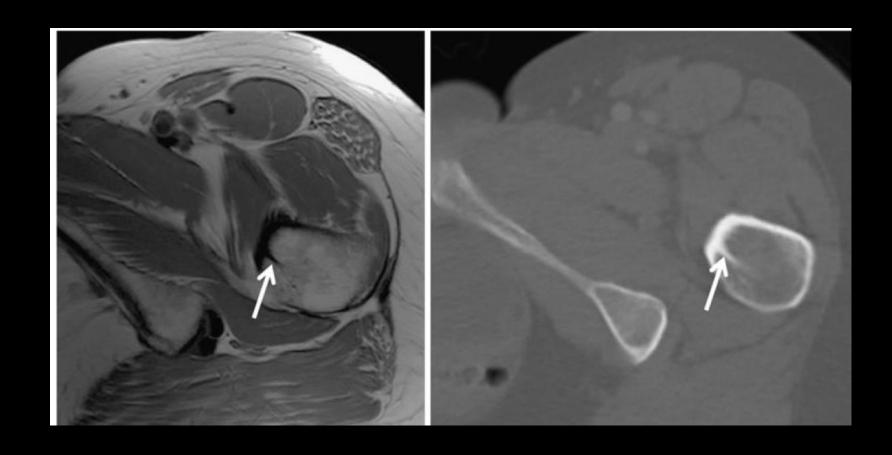
• Similar to femoral calcar
